# CVT Parts

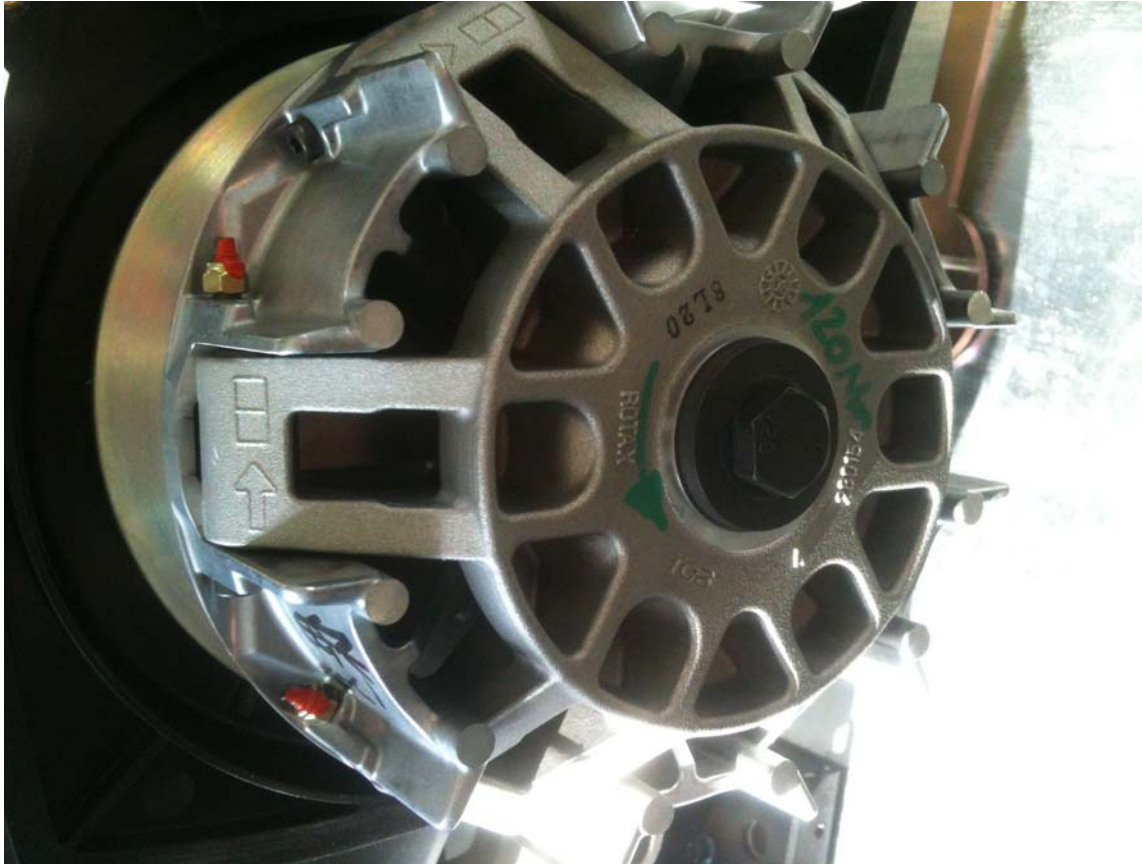
- The arrow on the governor cup indicates not the rotation direction of the engine, it shows the insertion direction of the sleeves. They should be pushed out against the arrow direction. Each time when replacing the roller sleeves mark the box next to the arrow with a tick. If the two boxes are already marked, the governor cup needs to be replaced.
- Important: Always replace the drive pulley screw when assembling. Never substitute conical spring washer and/or screw with aftermarket parts. Tightening torque is 120 Nm.
- The green arrow is showing the rotation direction of the engine.

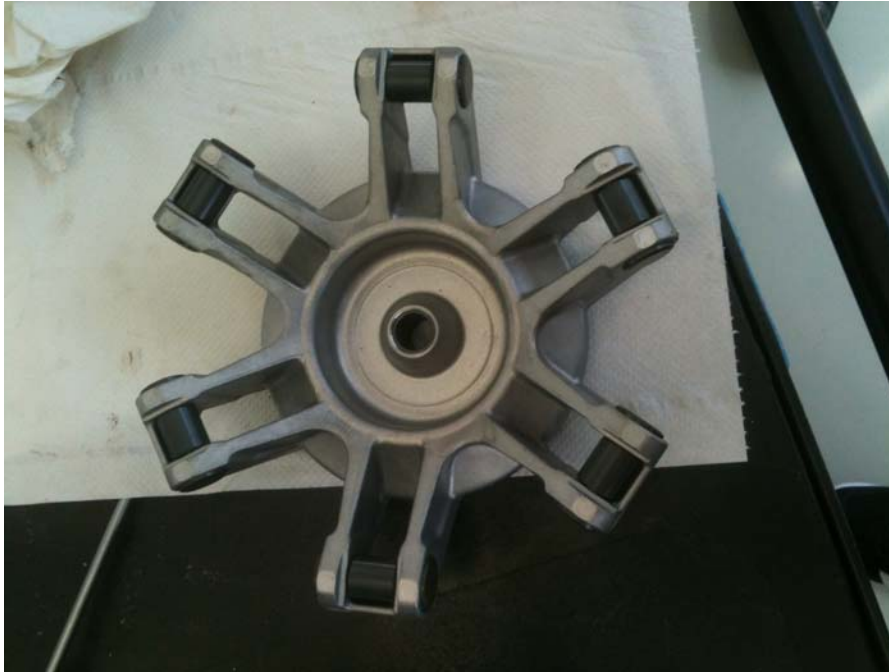
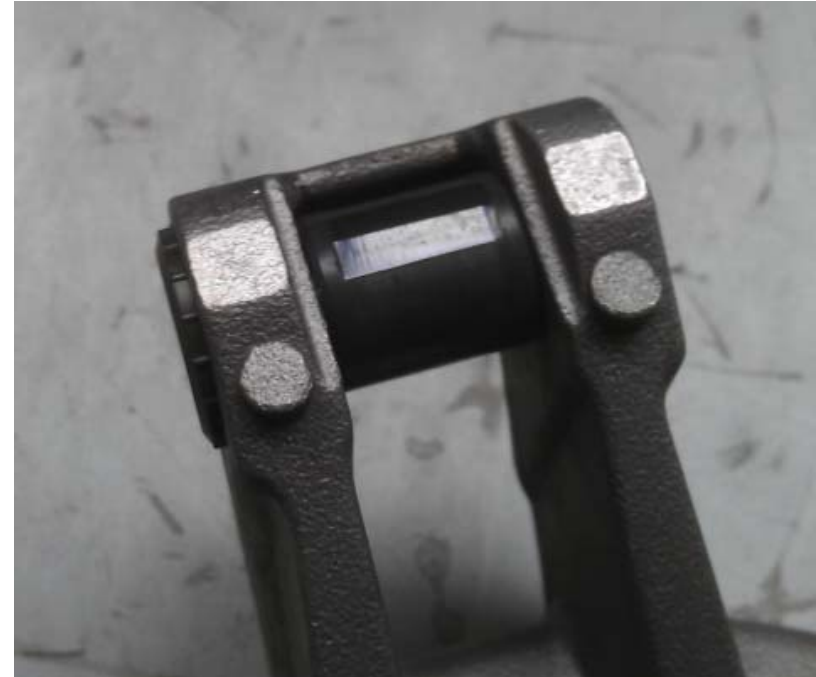
- The newest version of the Governor Cup (P/N 420280522) consists of the cone which is completely metal with a metal sleeve (this replaces the version with the alloy cone P/N 420280519). The new Vespel Rollers have been built into this new version
- These new Rollers become a flat spot after a short time of usage. This spot is uncritical. There is no need to change to roller unless the spot becomes bigger than ?mm? (awaiting answer from Rotax 12.06.2012) .
- The rollers can be replaced without replacing the lever arms
- The right pic. shows a roller after 500 km.

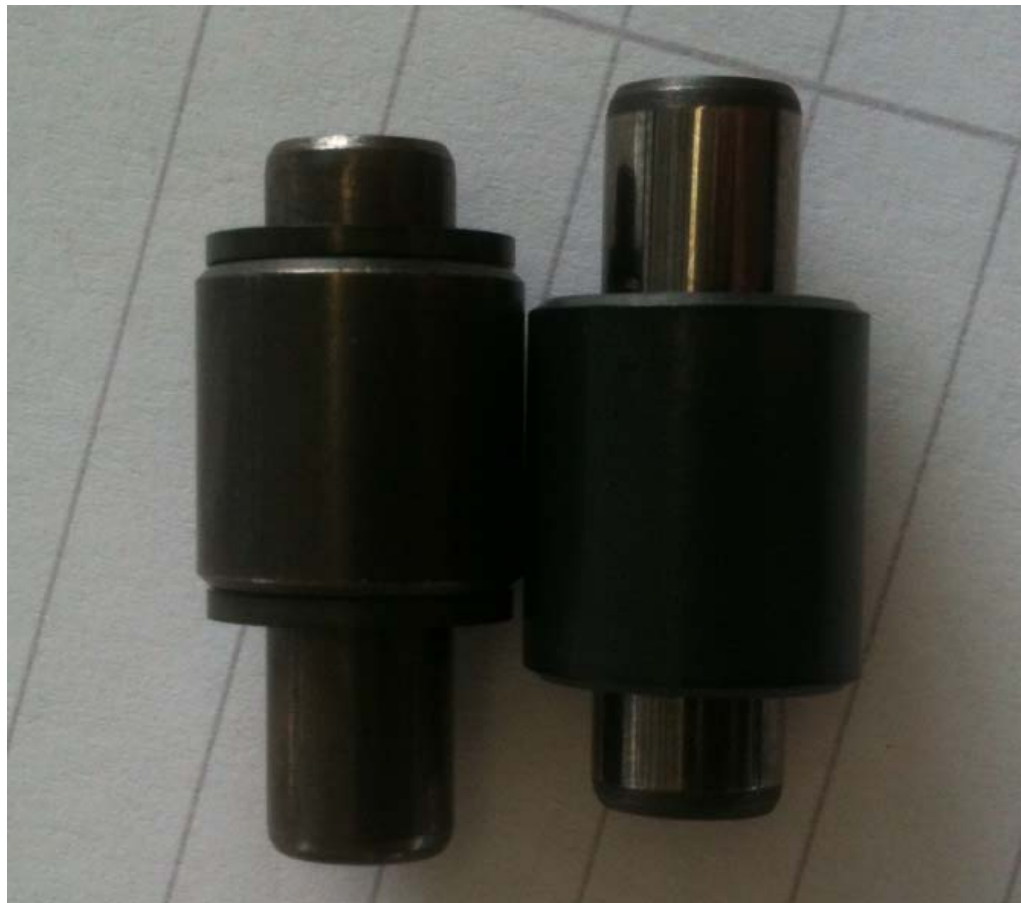
- The new rollers have no washers any longer.
- The surface of the sleeves is high gloss polished.
- Only assemble new rollers with new sleeves. Don't mix them!

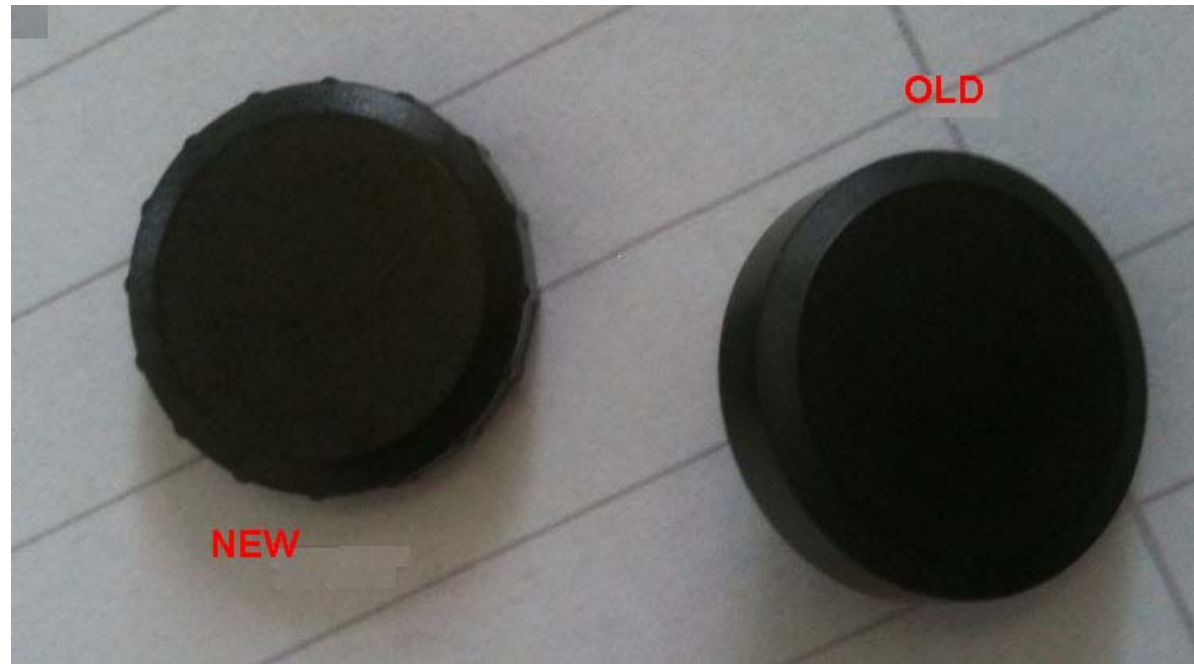
- A new version of slider shoes will be installed as a running change.
- SSV 800 & 1000: starts with MY12
- ATV G2 800, 1000: also starts with MY12
- ATV G2 650: starts with MY13
- ATV G2 500: still old version build in at rotax
- The P/N 420281293 will stay the same.
- The new slider shoes have 16 edges and no mounting support anymore.
- The new slider shoes will be hold on the outside by the governor cup.
- The slider shoe towards the engine rotation will have more wear than the opposite one. This is normal, because of the rotation and torque of the engine
- Always change all 12 slider shoes at the same time.

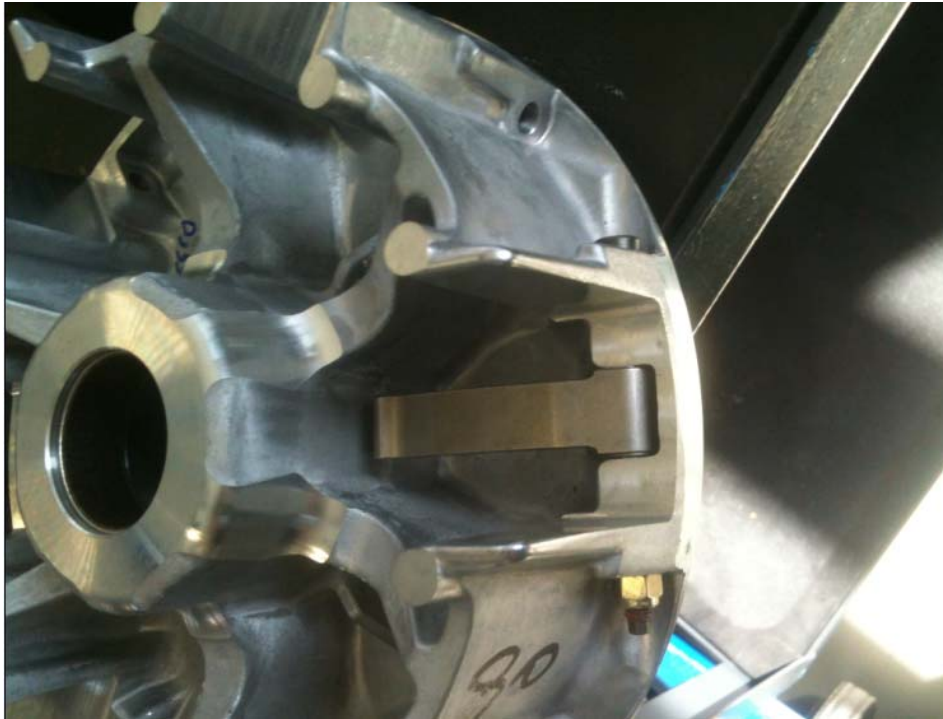
- The latest execution of the outer half P/N 420280467 is reinforced at the lever arm support.
- The lever arm pivot bolt is now free of slackness, not like the old version where the bolt is **floating mounted**.
- If a lever arm needs to be replaced, always replace all lever arms to avoid an unbalanced drive pulley.
- The lever arm which is hard to operate after the installation becomes low-friction after short usage.
- The pivot bolt should be installed from the right to the left (top view).
- When replacing the lever arms the bolt and the rollers needs to be replaced.

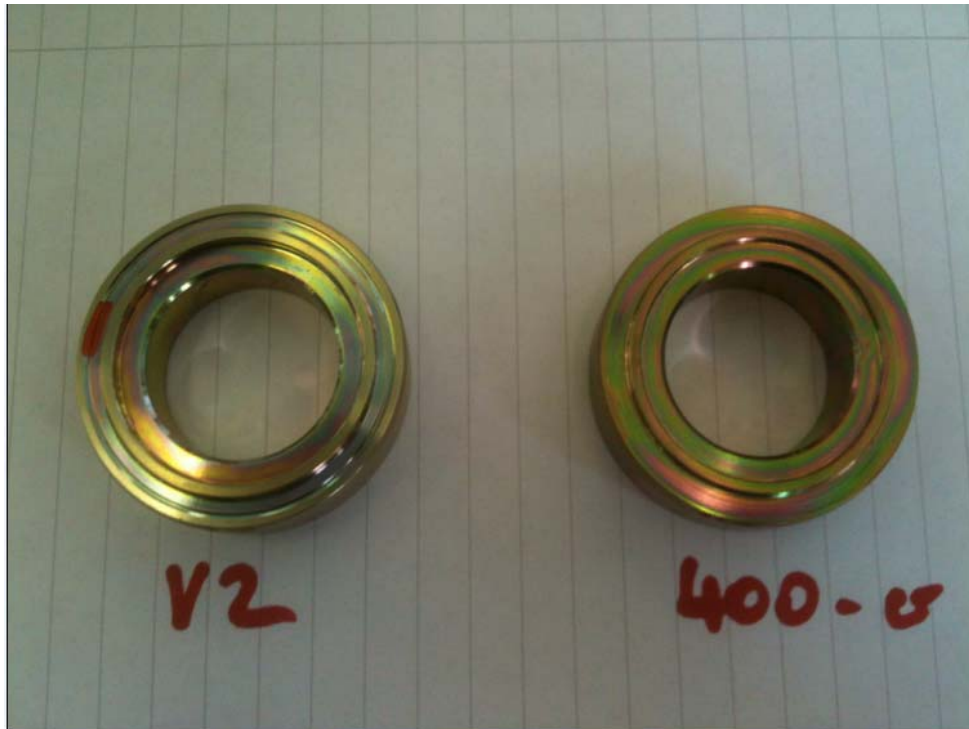
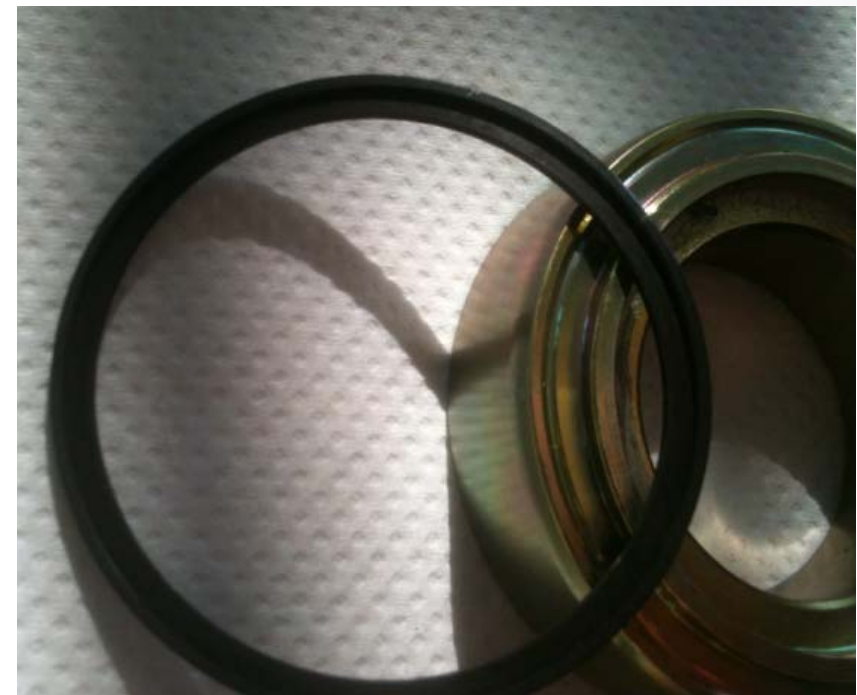
- Two versions of spring seats are built into ATV engines. The difference is that the spring seat for the V2 engines have a collar at the outer edge. (red mark)
- The friction washer is mounted on all engines except the 1010 and the 810 commander engine.
- The friction washer must be installed with its collar towards the one-way clutch.

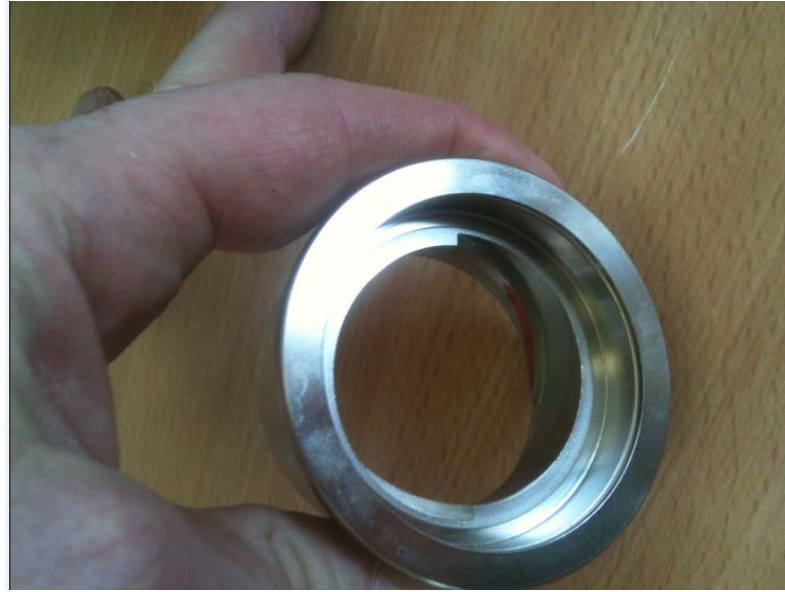
- The one-way clutch operates only in the red marked area.
- At the 400 cc engine the ramp has a reverse direction like the V2 engines. This is due to the inverse engine rotation.

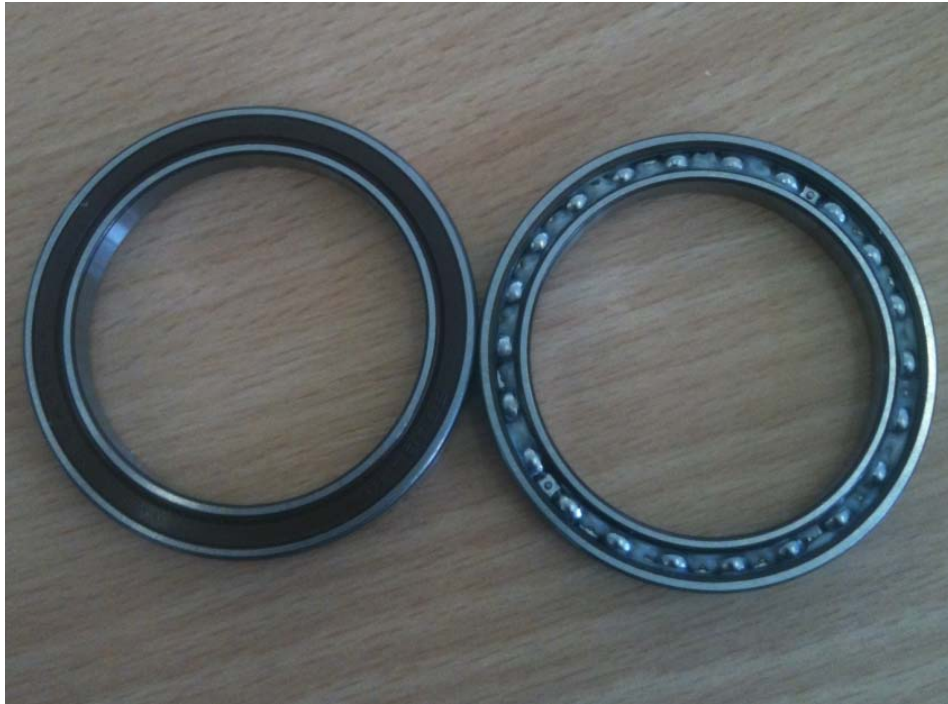
- The 2 ball bearings used in the one-way clutch are double side sealed. (except 1010 engine and Commander 800)
- The 2 ball bearings in the 1010 and Commader 800 engine are only sealed on one side (P/N 420632377). This was done because with the introduction of the new transmission, less drag is needed on the driven clutch. If there is too much drag on the new transmission, shifting will be adversely affected.
- The maintenance interval has been decreased from 2 years or 6000 km to 1 year or 3000 km.

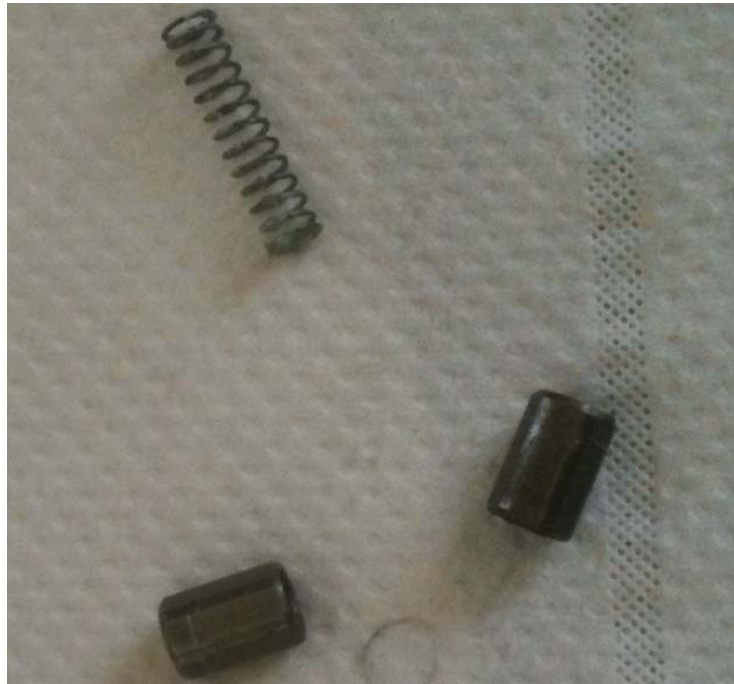
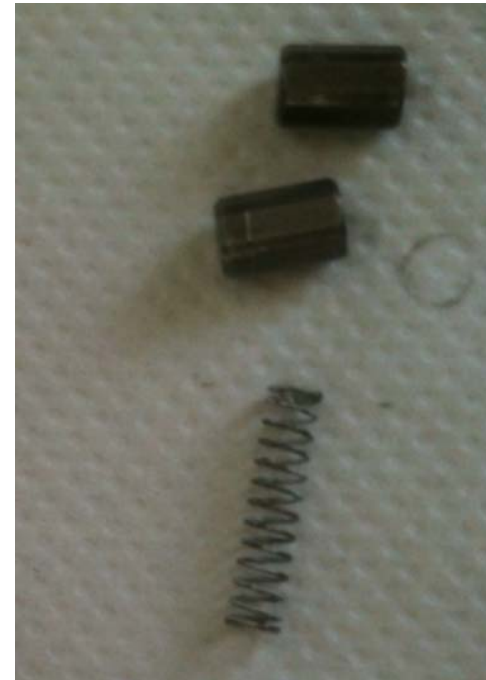
- The compression springs at the V2 engines are all the same types, regarding windings, length and compression rate.
- The compression springs at the 400 cc engine (P/N 420239135) have the same winding, length and compression rate like the V2 springs. But the winding direction is inverted. This is due to the reverse rotation direction of the engine.
- Take care not to install the wrong springs. If you have (for example) installed a 400 cc Spring on a 800 cc V2 engine, the spring will unwrap and loose their compression rate.
- The result of a damaged unwrapped spring is that you will lose the engine brake effect.

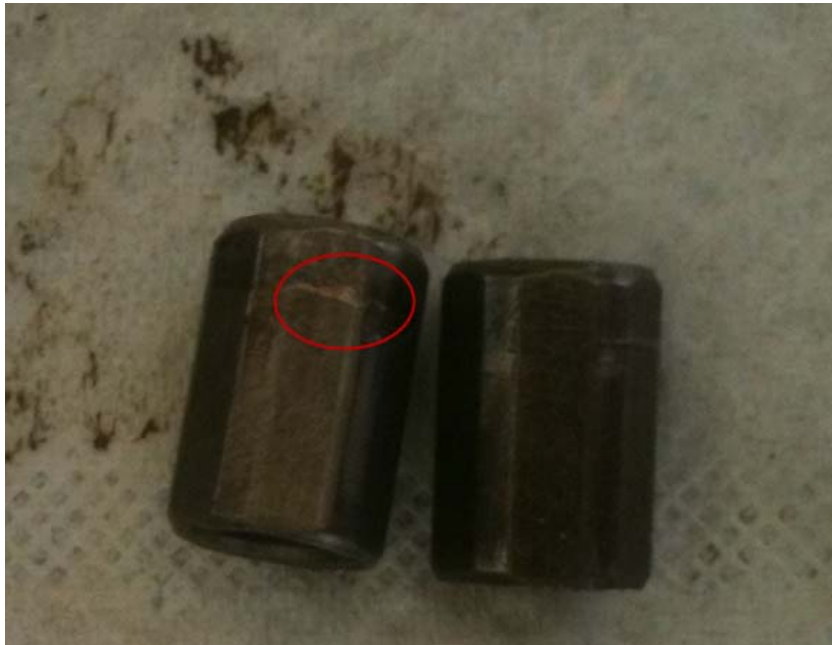
- If the spring sleeves are damaged or notched in the marked area, they need to be replaced.

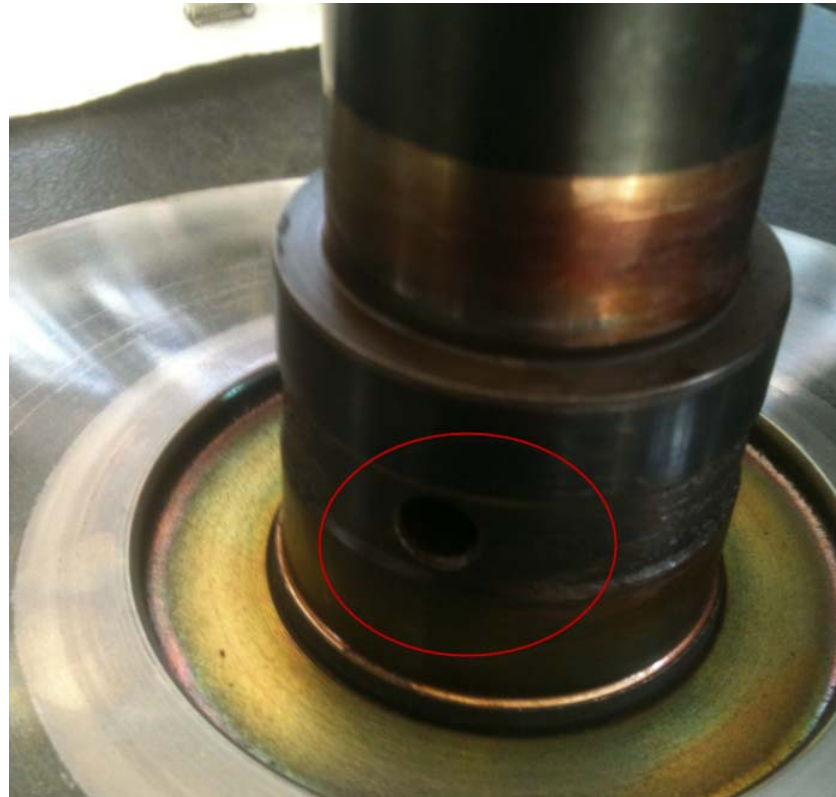
- Before you reassemble the one-way clutch inspect the sleeve holes for wear.

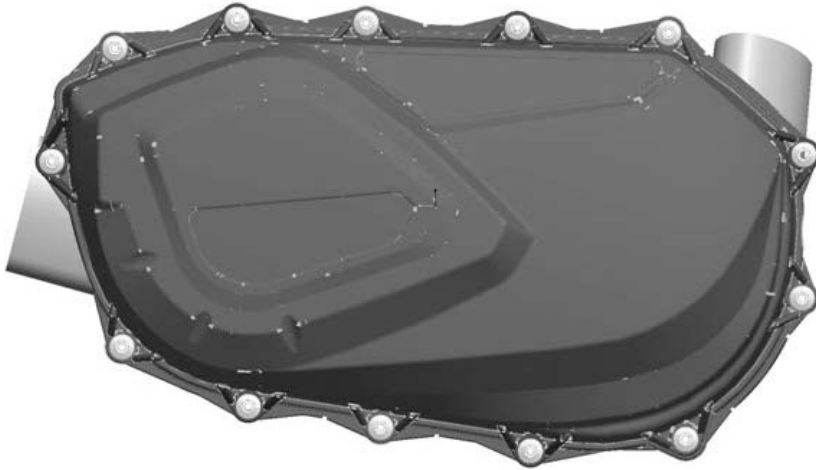
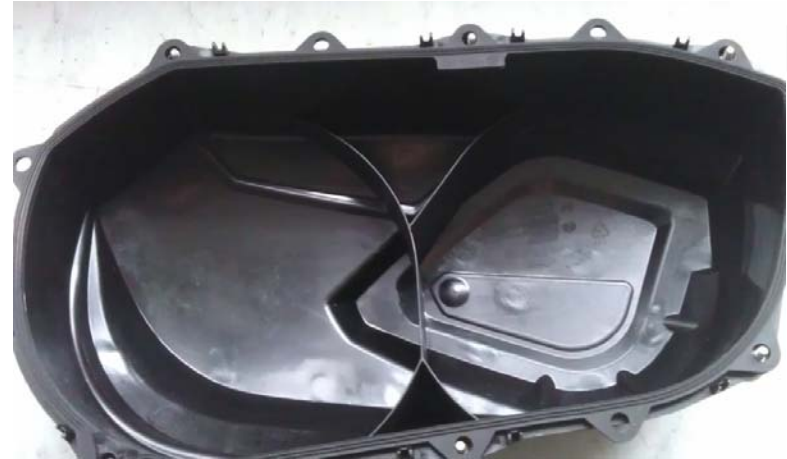
- The new seal of the CVT cover (P/N 420430126) has a new material mixture to avoid leakage. The replacement was done as a running change.
- Nevertheless these new seal retrofits the old 7 bolt CVT cover. The sealant is guranteed.
- The new CVT cover ( P/N 420611394) can be used with the old 7 bolt CVT air guide. The sealant is also guranteed.
- The crosspiece inside the CVT cover is related to the air flow and cooling of the CVT. If the crosspieces are damaged the CVT cover needs to be replaced.

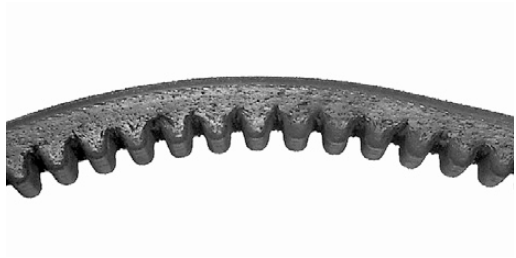
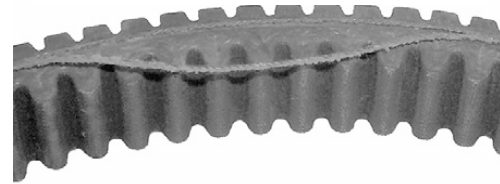
- On the top right you see a belt with a very frequent failure „belt spotting“. This failure occurs when
  - Inappropriate transmission gear selection during towing, steep incline or in deep mud/snow
  - Drive train locked or frozen
  - Accelerating motor while vehicle is stuck
  - Vehicle overload including excessive towing loads
  - Incorrect pulley operation from modified or dirty CVT components
  - Using high gear while climbing a hill.
- In this case the belt is held by the driven pulley and the drive clutch is slipping. Then there is too much temperature at the belt. As a result of this, the belt makes a squeezing noise during acceleration.
- For more information regarding belt damages refer to the Administrative Bulletin 2012-1

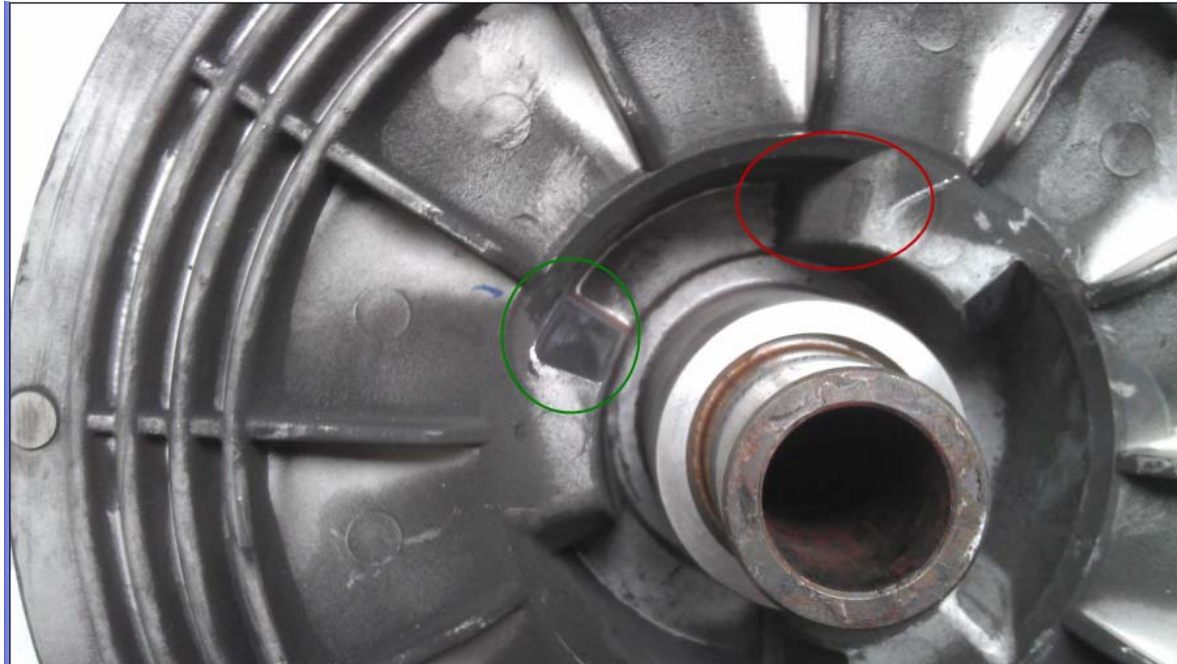
- At the drive pulley there are 2 different ramps.
- Red marked ramp: These ramp is responsible for the engine braking force. The wear on this ramp is low, because there is only a few torque transfered on this ramp.
- Green marked ramp: This ramp is used for acceleration. The wear is higher than at the braking side due to the engine torque that is working on the surface.

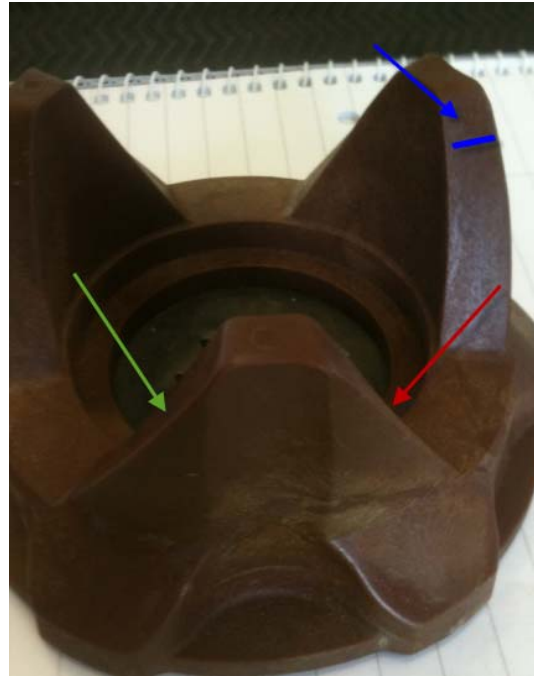
- Here you see a cam from an Outlander 650 (P/N 420280199).
- The green arrow shows the ram which is used during acceleration.
- The green arrow marks the acceleration ramp, which interferes into the Sliding Pulley. The acceleration ramp determines - in alliance with the springs and the leverarms - the speed ratio as a function of engine speed and engine torque. The flatter the ramp is prepared, the higher is the wedge power on the driving belts. With a flat acceleration ramp the number of revolution level is higher than with a steep ramp.

- The red arrow marks the decelleration ramp. The way of function is reverse to the acceleration ramp. The steeper the decelleration ramp the fewer is the impact of the engine brake.

- There are 2 different pairings of sliding pulley and cam. In the version shown above, a 650 engine, the locating surface is ounctual. This means the cam ramp touches the sliding pulley only at a very small face. These results a higher wear.

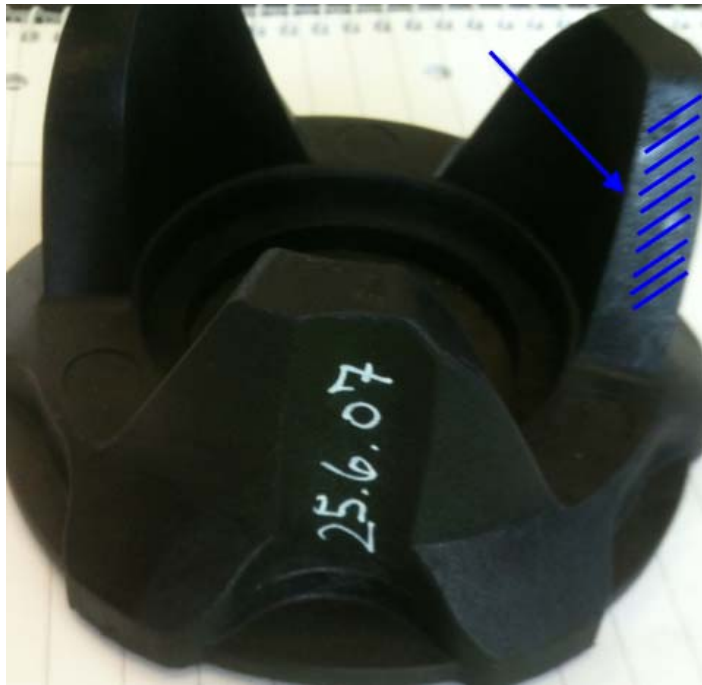
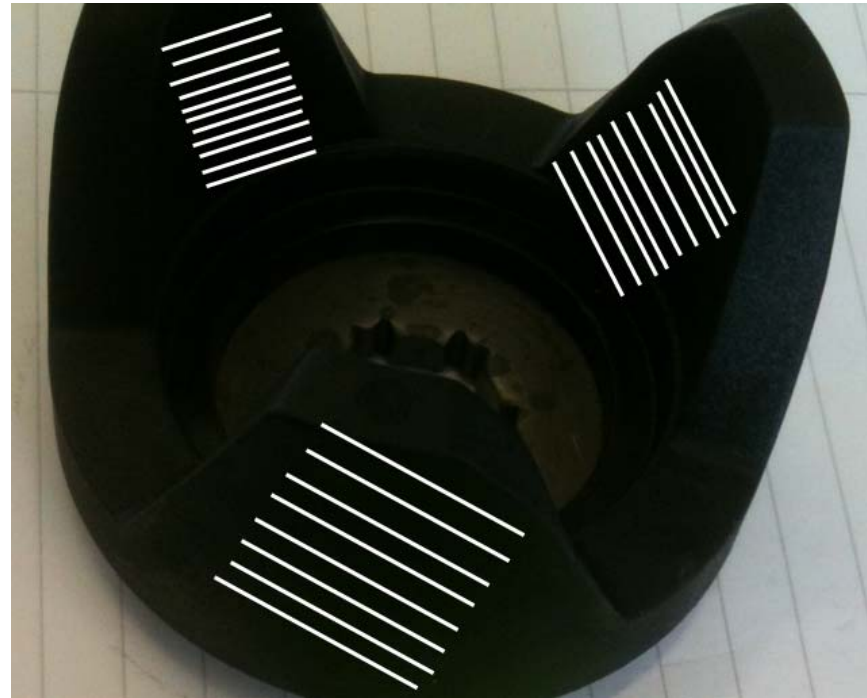
- On the left you see an Outlander 800 cam.
- Due to the higher power and torque the cam has contact on the complete surface of the sliding pulley (blue area). This reduces the wear of the sliding pulley and the cam.
- On the right you see an Outlander 1000 cam (P/N 420280472). The newest version of this cam is reinforced with a metal core in the teeth (white area). This makes the cam more resistant against shear off.

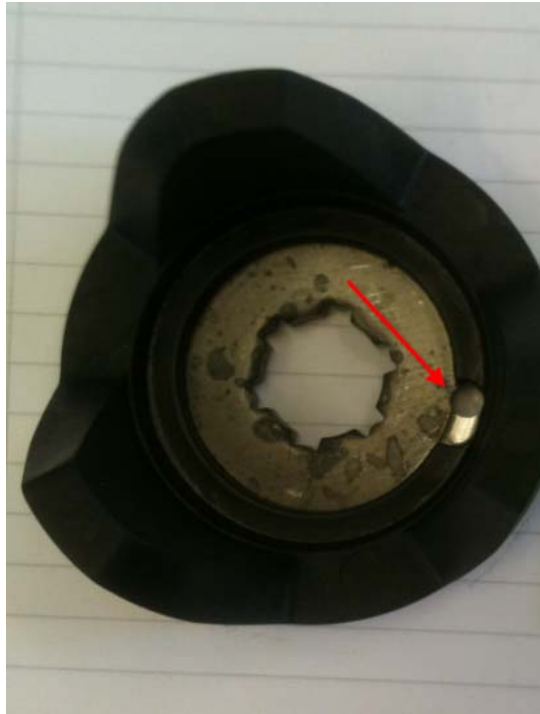
- This picture shows a cam of a G2 model. On this cam is a drilled hole where the top end of the compression spring needs to be installed. This new compression spring (P/N 420238177) effects that the accerelation ramp has contact with the acceleration ramp at the sliding pulley at idle speed. This effect avoids the metallic noise when starting to ride.
- You have to pay attention regarding the preload direction of the spring. A wrong preload direction results in contact between the brake ramp and the sliding Pulley a idle speed.

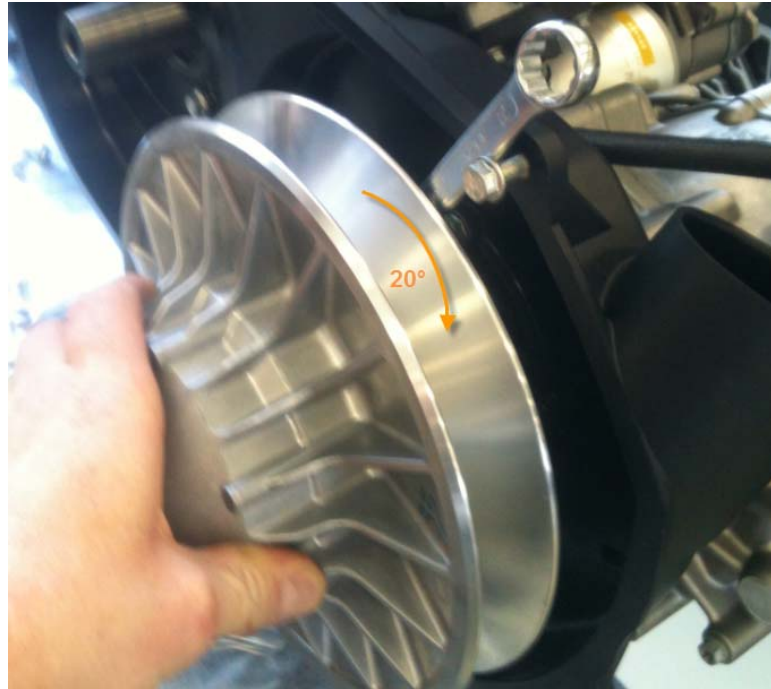
- While reassembling the driven pulley from the G2 model it is very important to twist the cam against the sliding sheave as shown at the picture.
- Turn the driven pulley 20° clockwise while the cam is blocked by a wrench until the cam engages in the driven pulley sliding sheave. Be careful when mounting the driven pulley to prevent damages at the cam or sheave.
- If you turn the pulley 20° counterclockwise you can assemble the driven pulley as well, but each time you start driving you will hear a loud noise from the CVT. This is caused by the cam which is striking against the sheave. This increases the wear and can damage the cam.
- A not correctly engaged cam will cause damage to the driven pulley and cam itself.

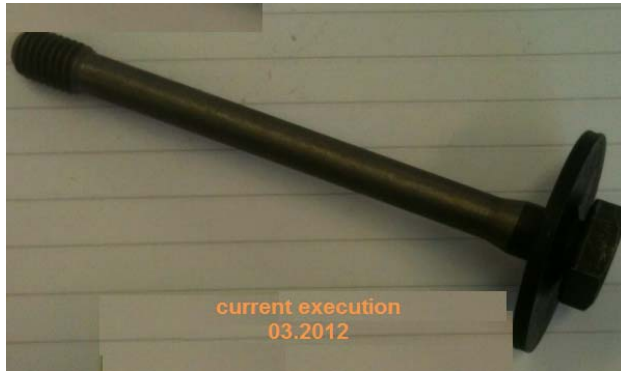
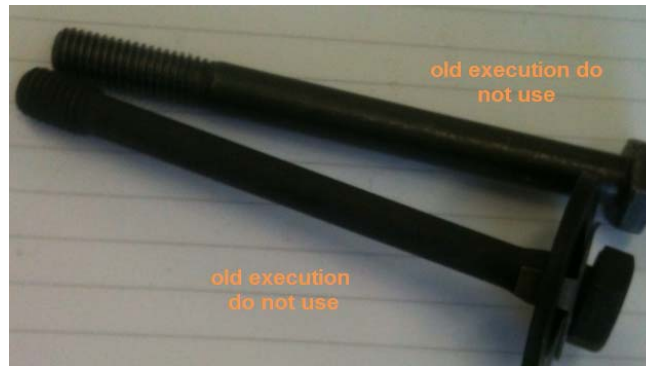
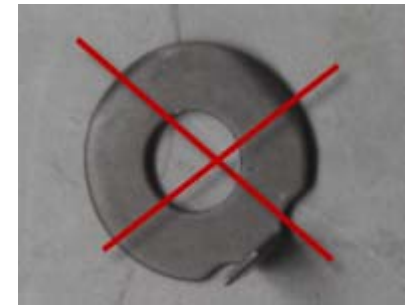
- When servicing the driven pulley on a vehicle equipped with a 1000 cc engine, install a NEW retaining screw.
- Strictly adhere to the tightening procedure. Step 1 tighten with 20 Nm. Step 2 turn 180° clockwise.
- When you see the driven pulley mounted with a tab washer, replace the screw through the current version.
