SKI-DOO, SEA-DOO, CAN-AM New Mpi-3 Interface Card Rev1_000106637 SER00Y015S00 en

Bulletin type: Service

Subject: New MPI-3 Interface Card

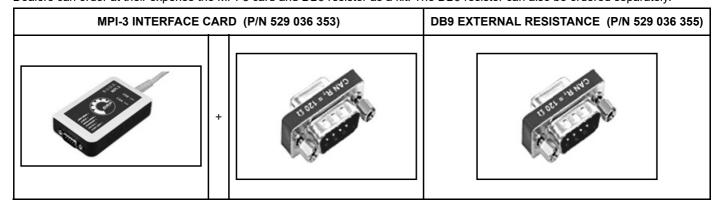
Dealers can order at their expense the MPI-3 card and DB9 resistor as a kit. The DB9 resistor can also be ordered separately.
