**SEA-DOO CERTIFICATION**

#### TRAINING

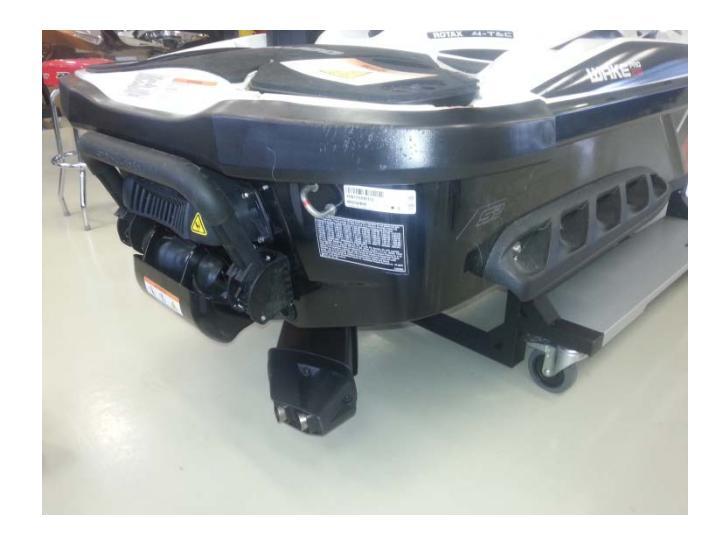
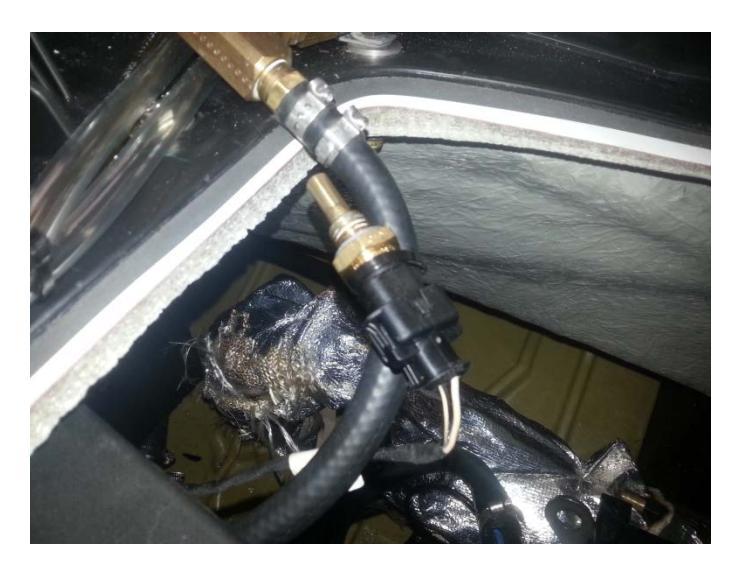
- The unit is modified with a dry exhaust
- EGTS is inside the hull -Room temp reading on BUDS

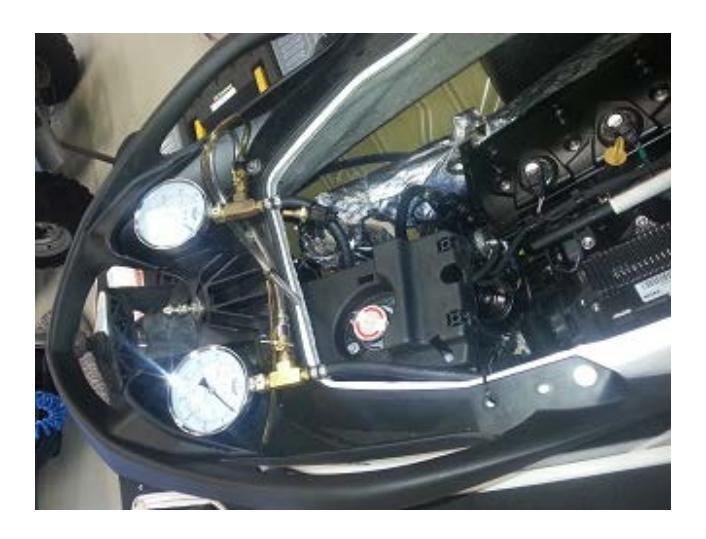
- Oil pressure gauges already installedOil pressure sensor removed
  - -Fault code on BUDS
- -Same pressure on both gauges
  - 2005 and prior had different pressure

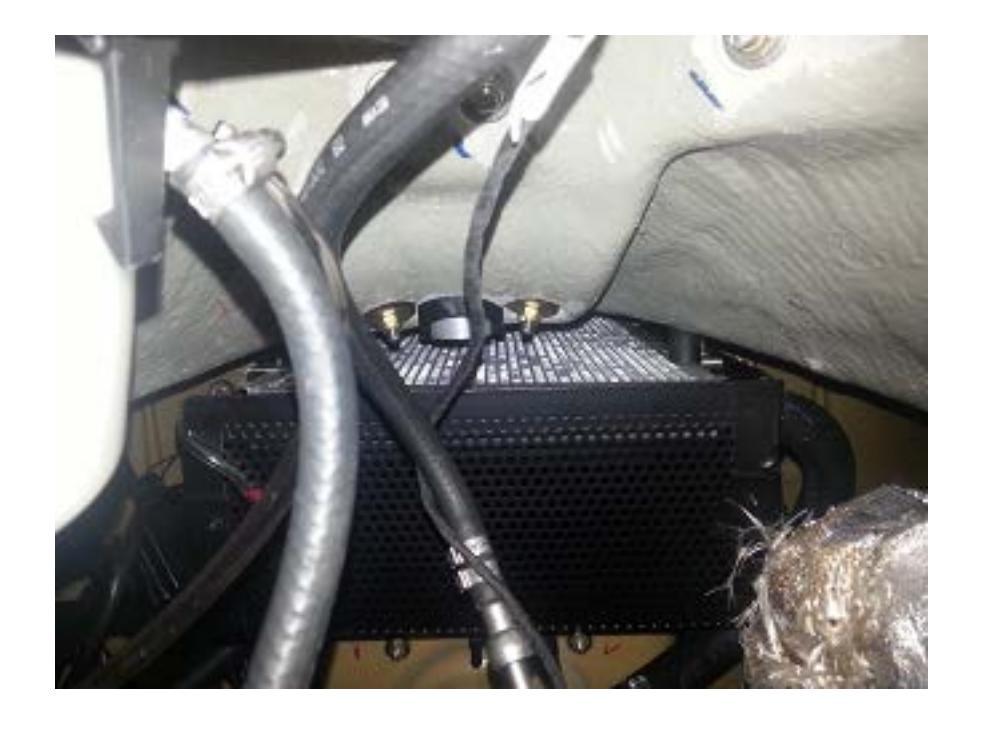
Internal radiator for coolingFan cooler activated by the fuel pump

-Internal radiator for cooling -Fan cooler activated by the fuel pump - The charging amperage will be higher than the specifications on the shop manual due to the fan cooler amperage consumption.

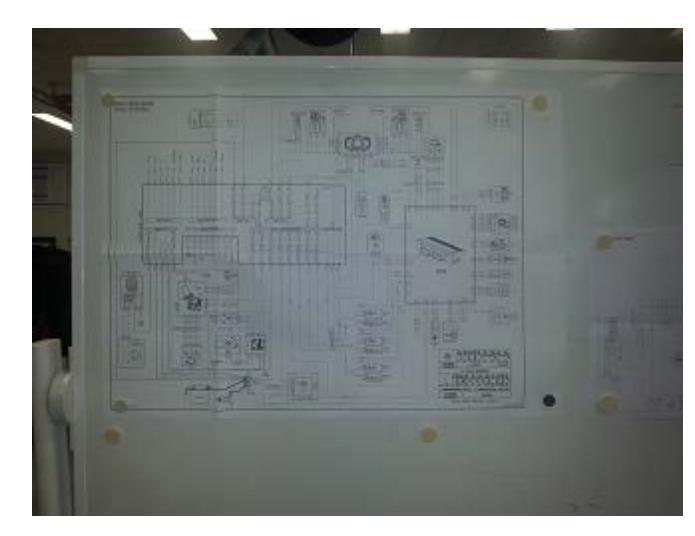
-LED is used for injector output test -It has a 500 ohm resistor inline to convert 12V to 2V

-The switch #8 has a resistor in parallel to create extra resistance on the CTS. No fault code but wrong reading on the monitoring page.

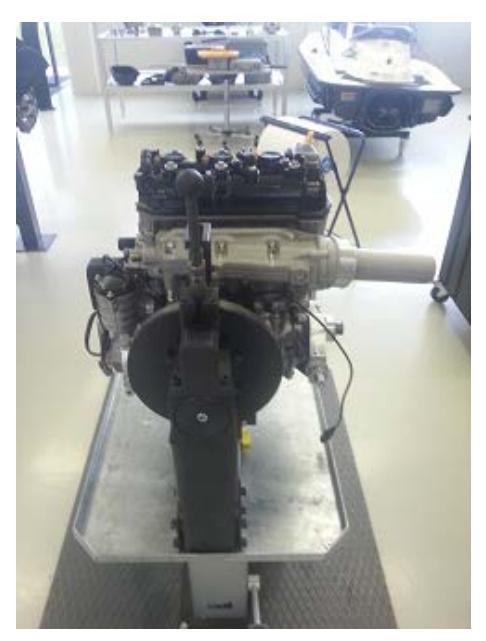
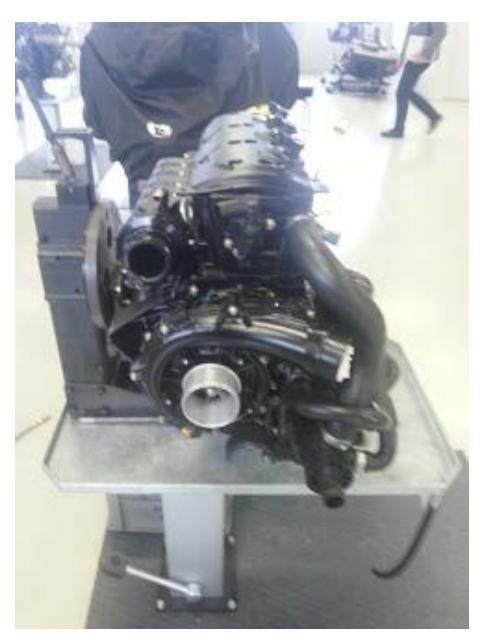
### STATION 11 STATIC ENGINES

- Timing procedures on both engines
- I eak down test
  - 1503: Leaking to crankcase and to cooling system
  - 903: Leak on the exhaust and intake valves.
- Better to try another leak down kit. It seams to reduce the pressure too much.
- Broken bolt on the camshaft holders: 420440324
- Air supply will be installed on the corner for better access. (Johannes)
- The tool trolley is used only for this station + the special tools.

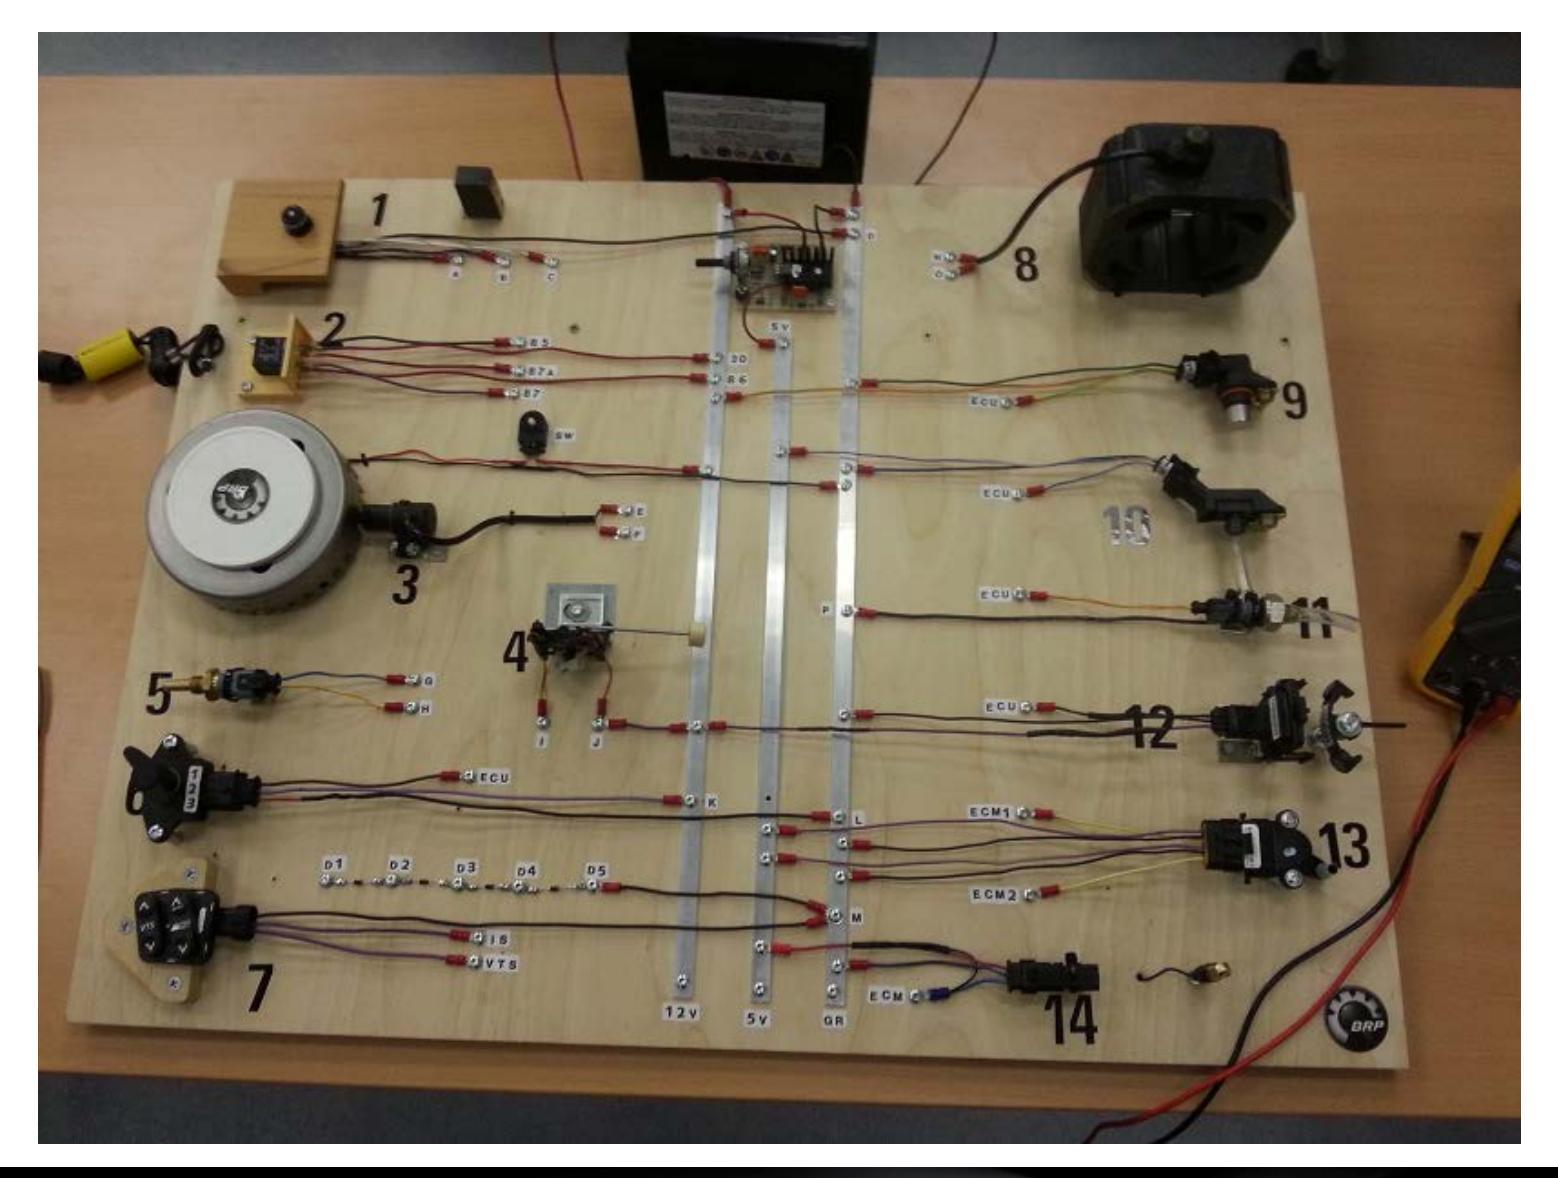
#### STATION 30 SENSORS BOARD

- There is PWM to convert 12v to 5volts. It will be good to buy another one.
- It is adjusted by turning the knob slowly. The voltage should be measured between the 5V line and the ground line (right one)
- There is a magnet to activate DESS post without the key.
- OTAS: There is a 7300 ohms resistor between ECU and +12volts terminal
- TOPS : There is a 2200 ohms resistor between ECM and +5volts terminal
- The test light is shared with the station 26. Don't mix it with the 6 to 24 volts test lights.
- The diode on this station has no resistor. Don't mix with the others.
- The valve TOPS is only for understanding.
- Don't spin the flywheel too fast.
- Use dielectric grease to avoid damages on the wire seals when back-probing

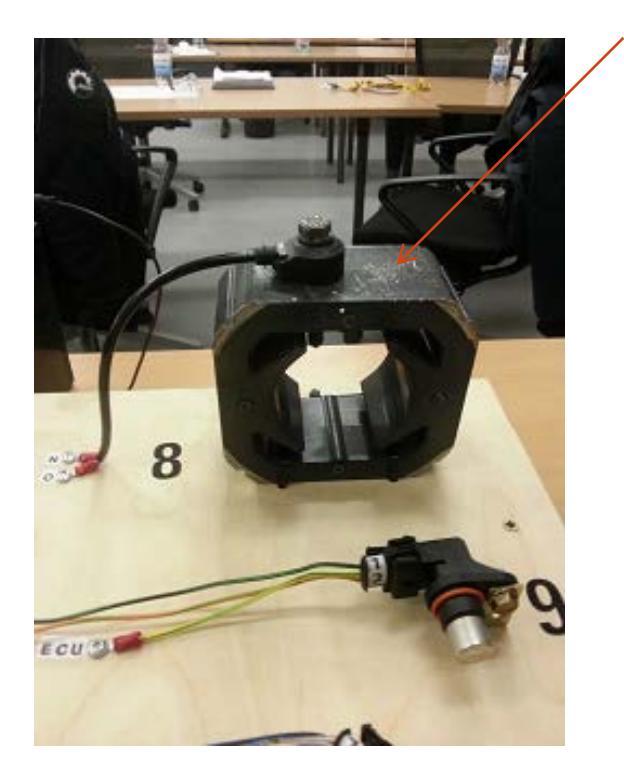
#### STATION 30 **SENSORS BOARD**

Knock sensor mounted on a piece of metal. Hit the metal to create vibrations Don't hit the sensor nor the bolt.

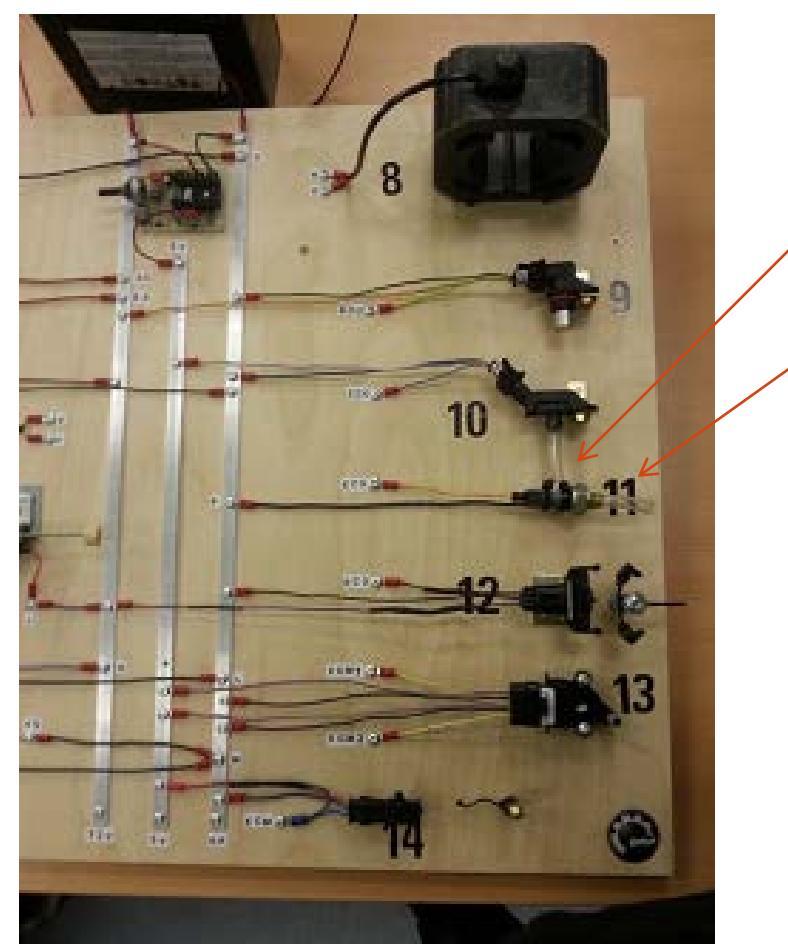
#### Pressure sensors with hoses already fitted

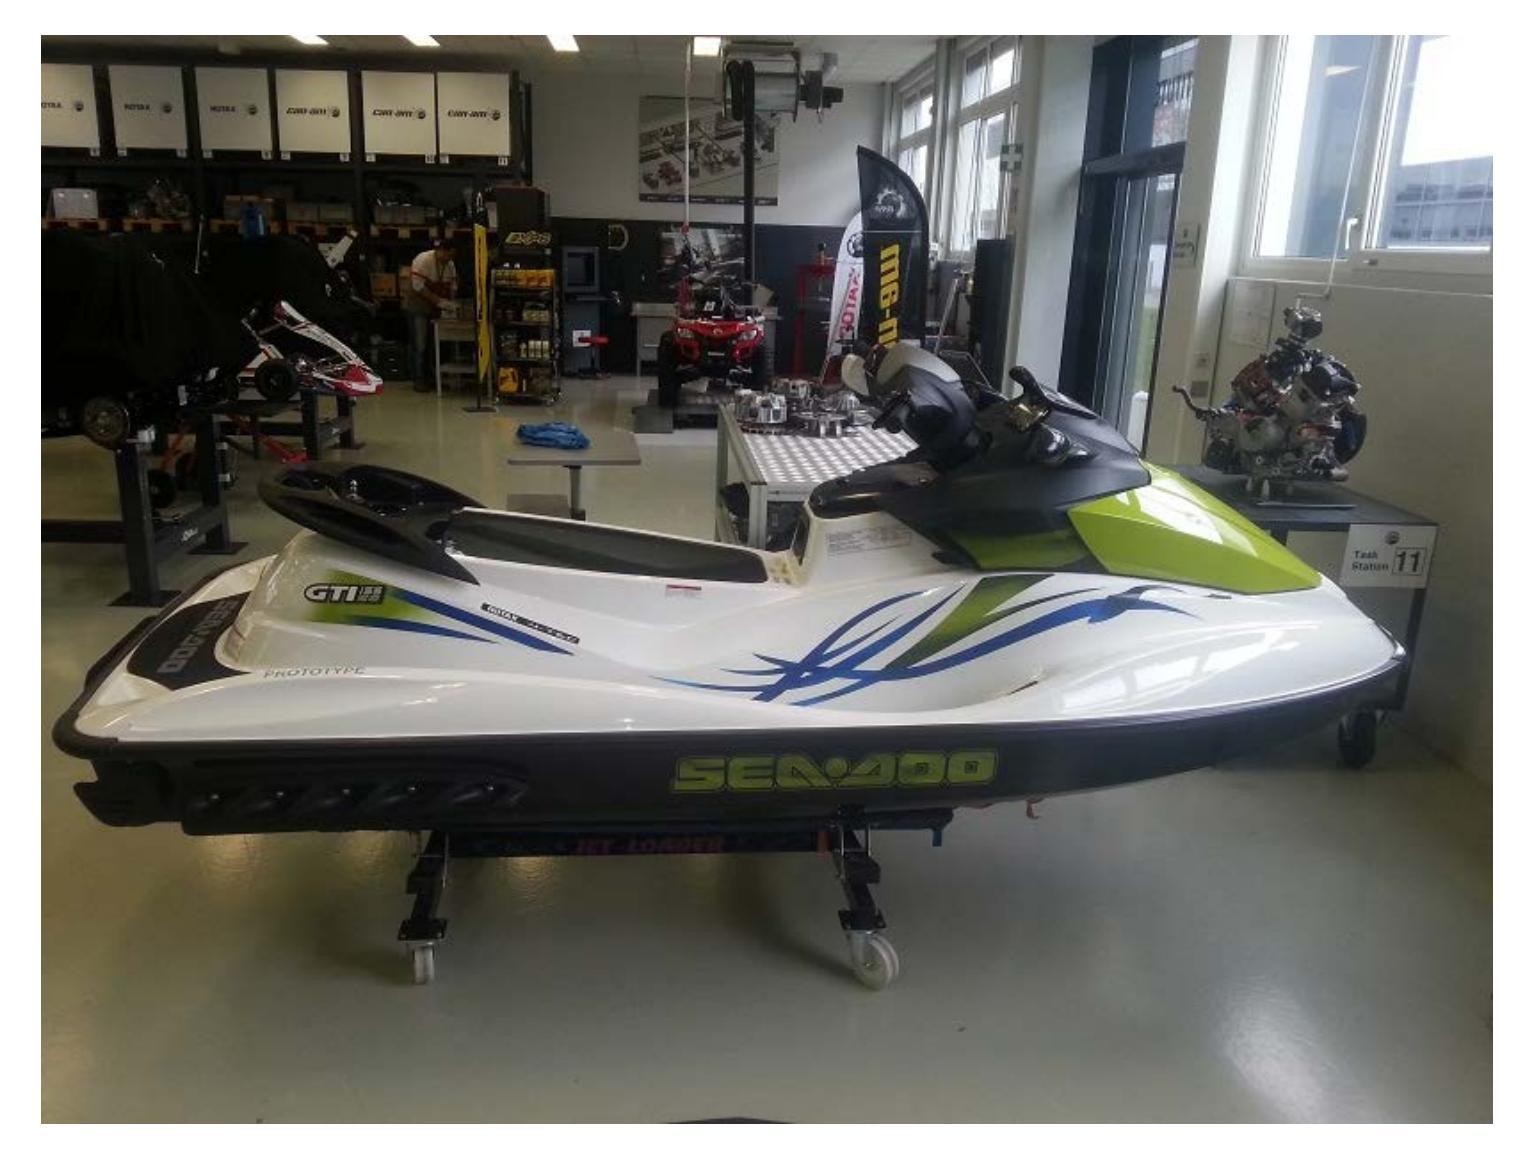
#### **STATION 31 PROPULSION**

- The engine is misaligned so the alignment shaft will touch the PTO adapter at +/-11:00
- The jet pump cap tool for the pressure test fits but it is only possible to install one bolt. This unit has a plastic pump and the tool is probably for the aluminum one.

- The shop manual only shows one part number for this tool. ????
- To tight he alignment plate to the hull you need some supplements since the threaded studs are quite long. I used 4 M12 nuts. Any other thing can be used (sockets, pipes)

- It is quite possible the c-clip falls under the engine during removal. That's why I added the magnet on the tool list.
- The two plastic boxes are used for the removed parts.

- I recommend to perform the jet pump pressure test with the jet pump still on the unit with the minimum parts removed since is something that rental operators can do preventively.

- After checking the anode continuity you can ask them to check the one on the GTX LTD iS ride plate. That one looks good but has no continuity.

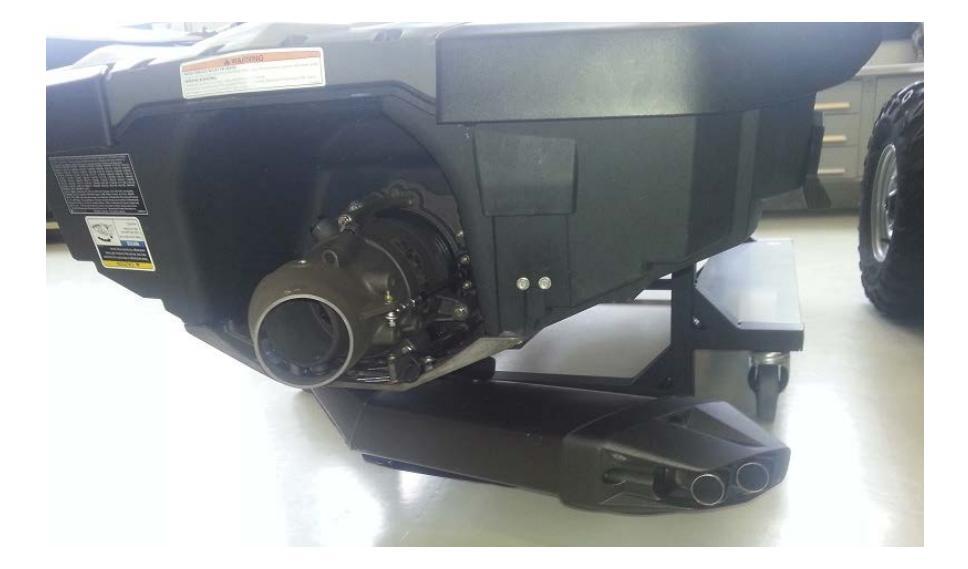
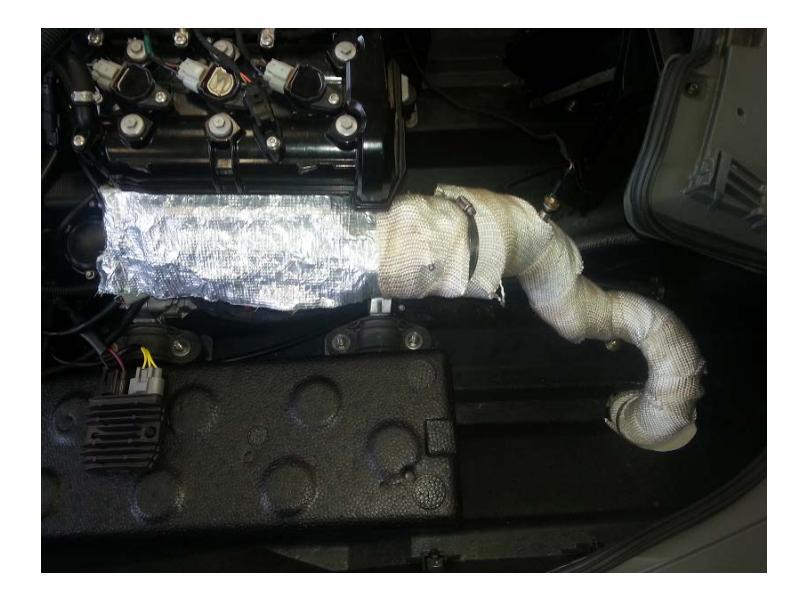
#### STATION 40 Running 903

Dry exhaust:

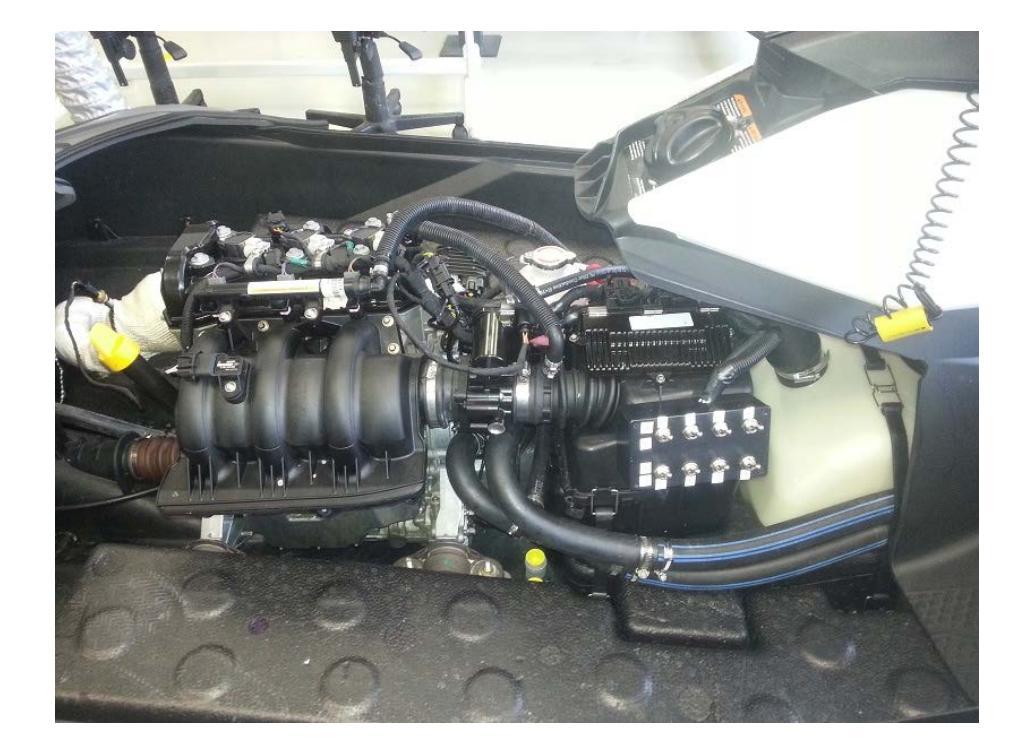
#### STATION 40 **Running 903**

Switchable faults:

The switch #8 doesn't work. It doesn't stop the unit consistently. Task removed

-Wiring diagram on the wall -Charge battery every night -Charge Notebooks every night -MPI inside the Notebooks box
